# Manhole Inspection Summary

# Manhole # S17Q\_\_003MH

**Location** Address: **2687 EAGLE ST**

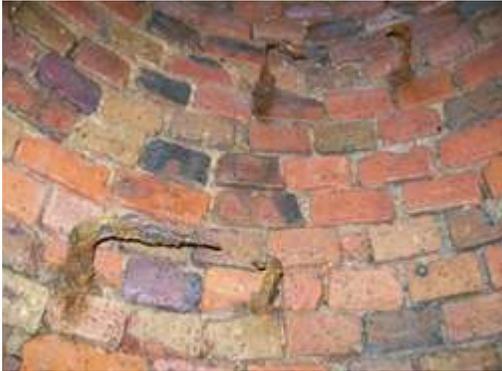
Defect 3

**Steps** Count: **5** Missing: **4**  **Corroded**

MISSING/CORRODED STEPS

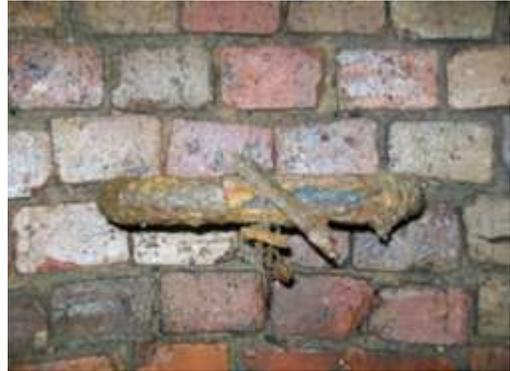
Defect 2

**Surcharge**  **Evidence Of Surcharge** Depth: **5** (ft.)  Active Surcharge Present

SURCHARGE EVIDENCE ON STEP

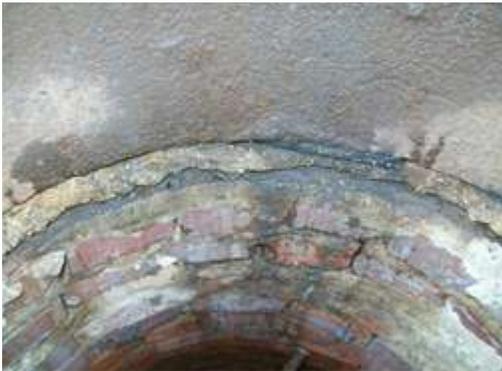
Defect 1

Condition:  Sound  Cracked  Root Intrusion  Loose Brick  **Deteriorated**

DETERIORATED CHIMNEY

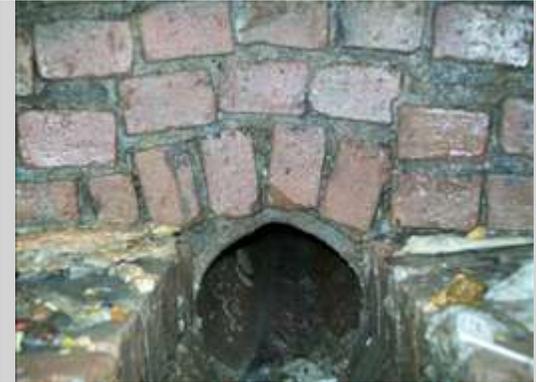
12 O'Clock Outflow

8 in. Circular Gravity Sewer  
Pipe Out @ 12 O'Clock

Pipe Height: **8.4** (in.) Rod and Bar (Angled)  
Pipe Material: **Clay**  Pipe Lined  
Invert Depth: **16.00** (ft.) Flow Characteristics: **Slow**  
Deposits:  None  Mud  Sludge  Debris  Grease  
Silt Depth: **0** (in.) Deposits Extent:  
Infiltration: **None** Pipe Seal Cond: **Sound**

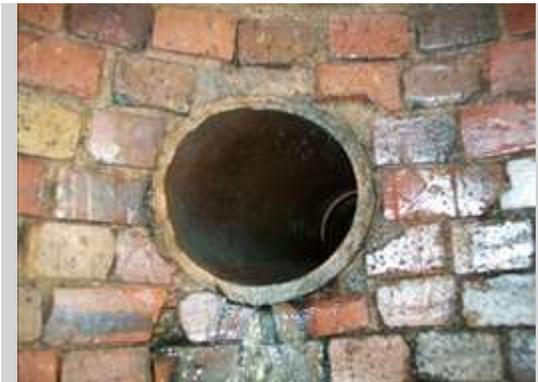
6 O'Clock Inflow

8 in. Circular Gravity Sewer  
Pipe In @ 6 O'Clock

Pipe Height: **3.6** (in.) Rod and Bar (Angled)  
Pipe Material: **Clay**  Pipe Lined  
Invert Depth: **6.00** (ft.) Flow Characteristics: **Slow**  
Deposits:  None  Mud  Sludge  Debris  Grease  
Silt Depth: **0** (in.) Deposits Extent:  
Infiltration: **None** Pipe Seal Cond: **Sound**

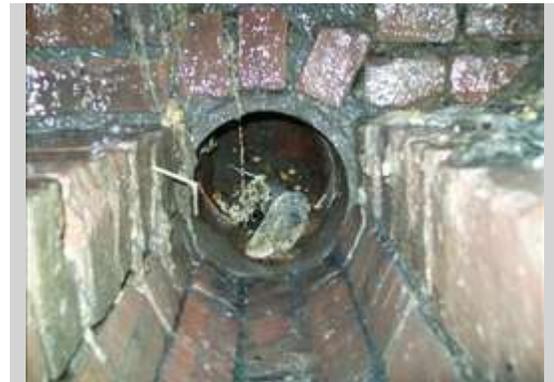
Drop In @ 6 O'Clock

Drop: **Outside**  
Angled: Reading: **14.40** (ft.)  
Inv Depth: **14.75** (ft.)  
Drop Condition: **Partly Clogged**

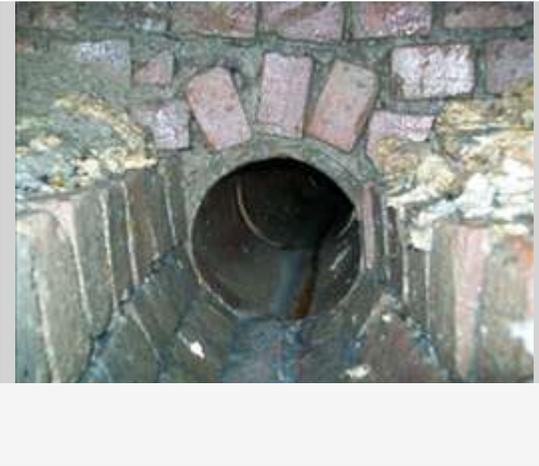
9 O'Clock Inflow

Pipe In @ 9 O'Clock

Connects To: **Dead End**
